Daily Report For 2016-05-19

Metal Bank

Sheetpile Repair
Cottman Avenue
Philadelphia, PA (US)
Report number: 3340011G-10
Date: May 19, 2016 01:08 PM

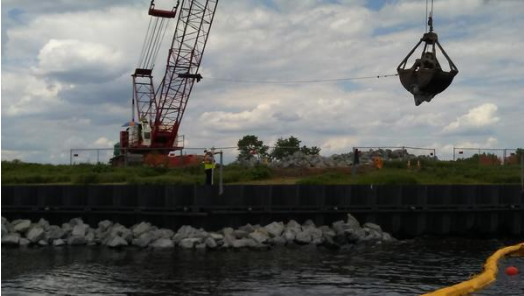
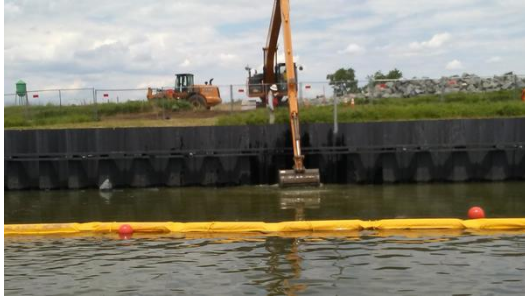
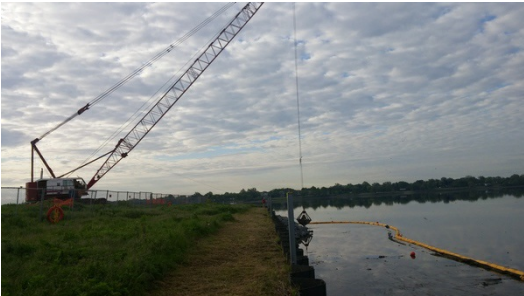
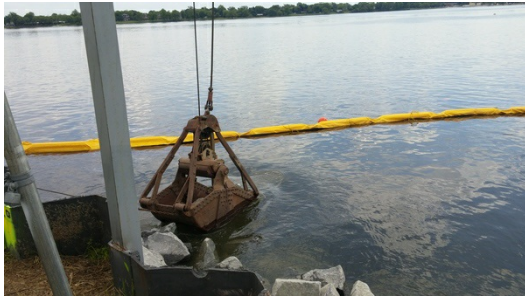
Remark	Description	Assignee(s):
Rip-Rap		
✓ R6 stone placement [3.1] May 18, 2016	(see pics below) <div>

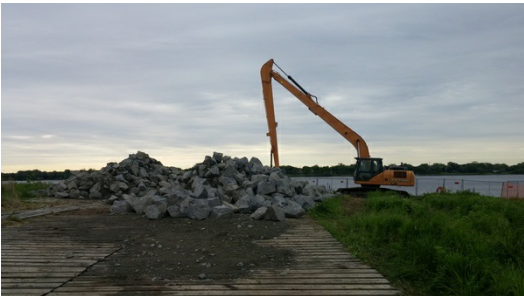
</div>	
✗ R6 stone stockpile extends beyond crushed stone pad [7.1] May 18, 2016	CEI continued to address some of this concern today and will address the rest tomorrow. <div>
